NL INDUSTRIES/TARACORP SUPERFUND SITE GROUP
2209 Quarry Drive, Suite C-35
Reading, PA 19609
Telephone: (610) 670-7310
Facsimile: (610) 670-7311

Re: NL Industries/Taracorp Superfund Site; Granite City, Illinois
First 2022 Semi-Annual Operation and Maintenance Inspection (June 28-29, 2022)

**NL Industries/Taracorp Superfund Site
Inspection Log - Operation and Maintenance**

Inspection Date: June 28, 2022

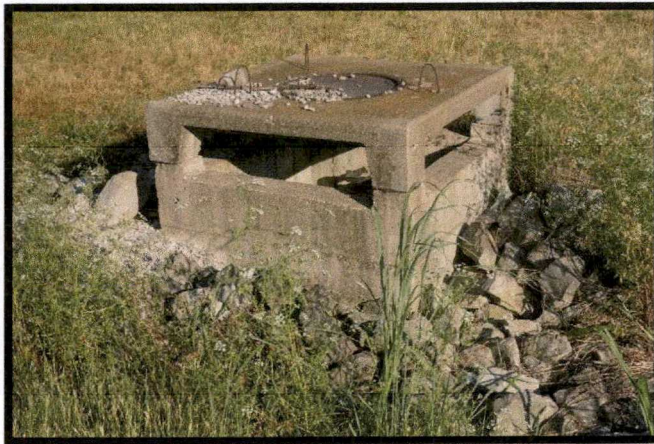
Photograph 44: Stormwater outlet.

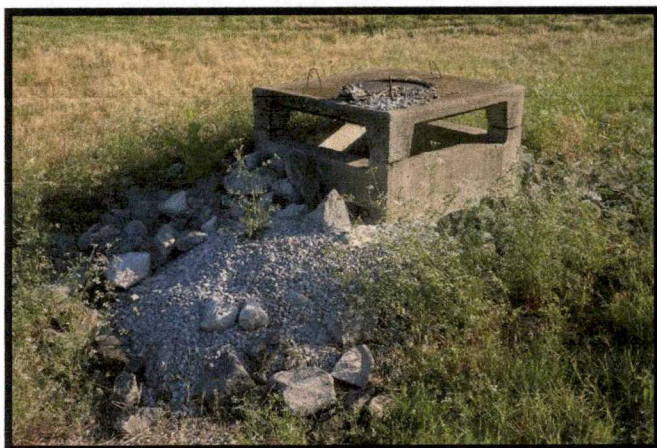
Photograph 45: Stormwater outlet.

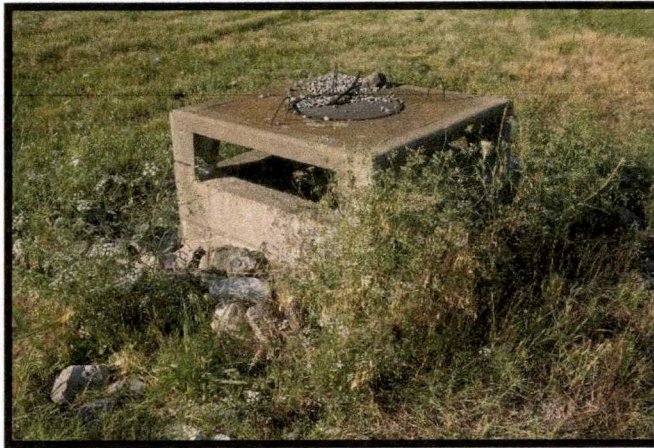
Photograph 46: Stormwater outlet.

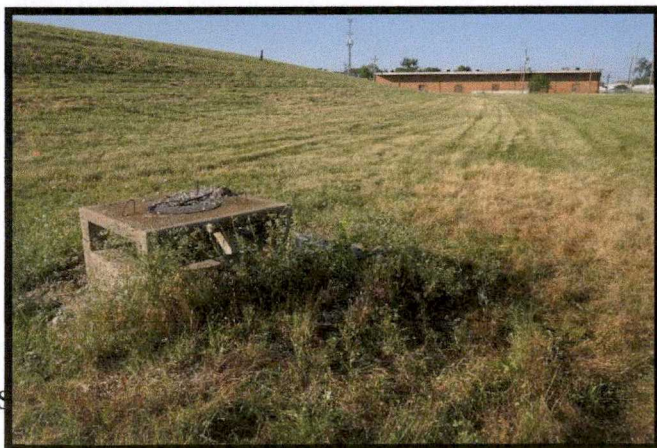
Photograph 47: Stormwater basin and outlet.

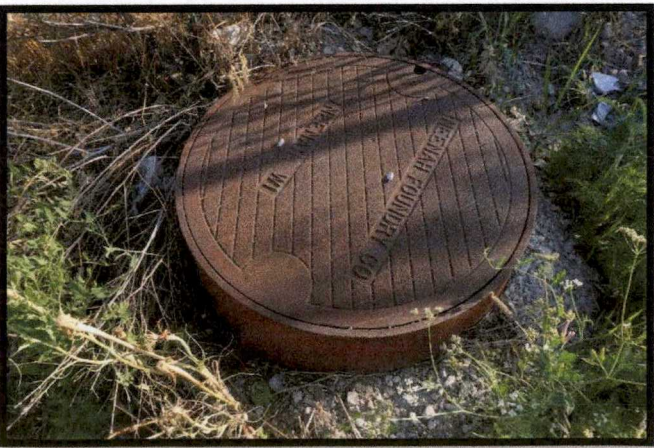
Photograph 48: Stormwater manhole.

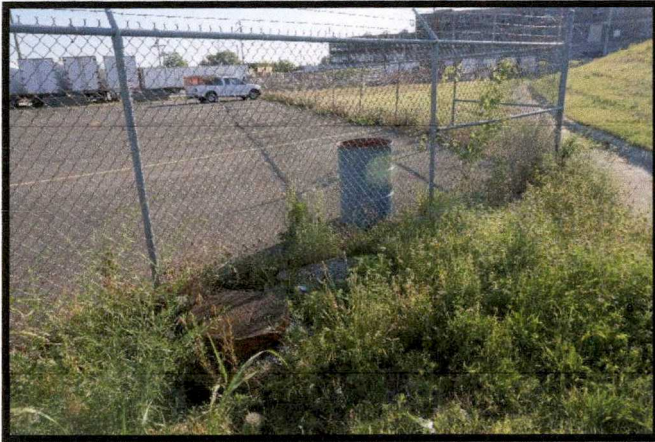
Photograph 49: Stormwater manhole, fence along south side of 1555 State Street property.

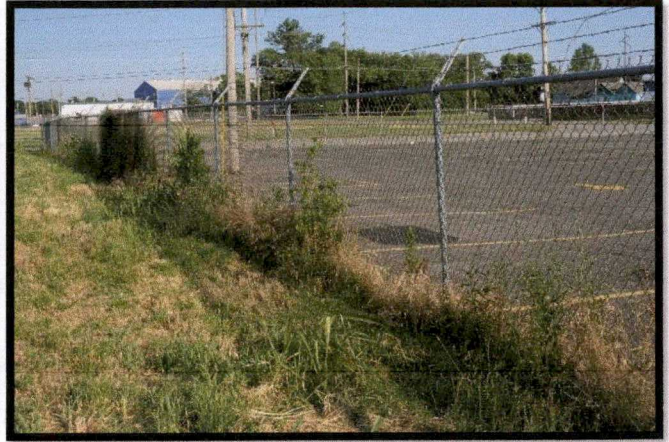
Photograph 50: Vegetation and fence along south end of 1555 State Street property (view toward State Street).

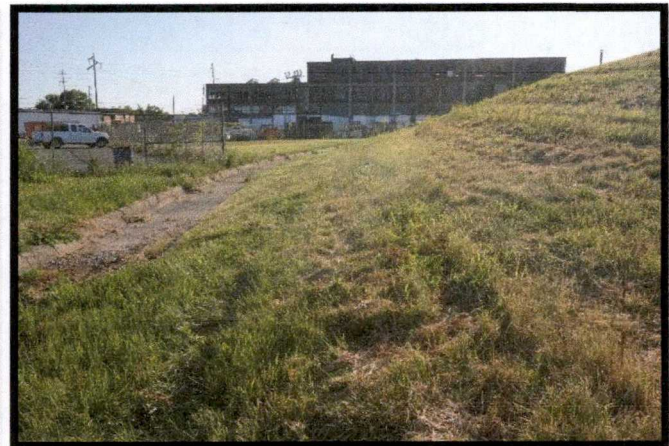
Photograph 52: Vegetation, southeastern side of Taracorp pile cap (view west).

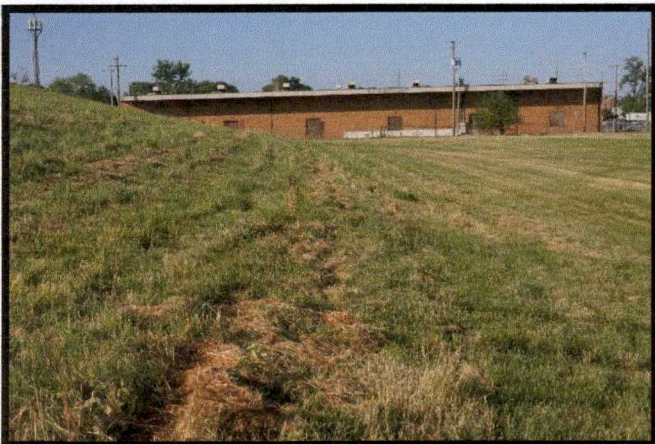
Photograph 53: Vegetation, eastern side of Taracorp pile (view northeast).

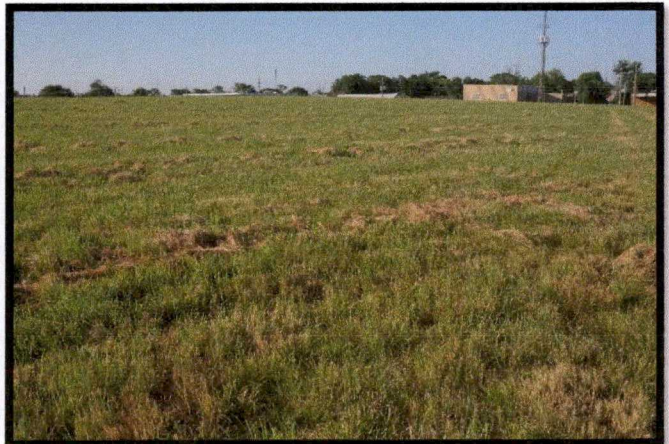
Photograph 54: Vegetation, top of Taracorp pile cap.

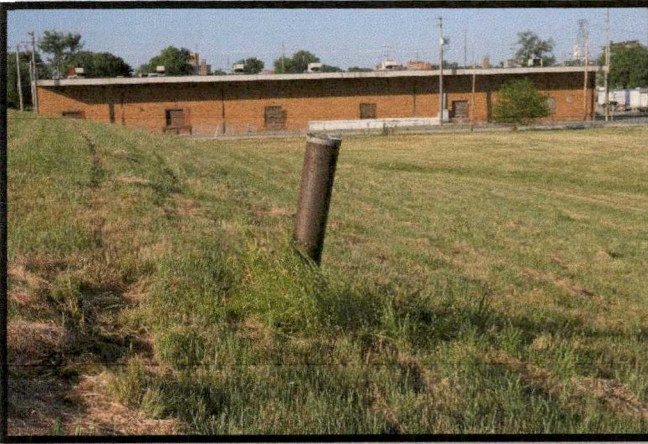
Photograph 55: Leachate riser pipe, vegetation on eastern side of Taracorp pile cap.

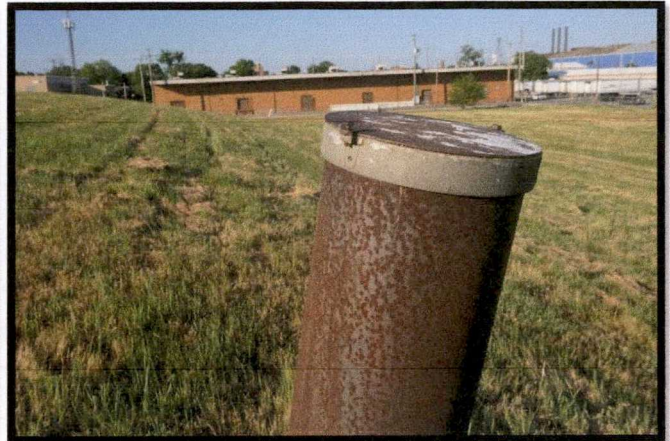
Photograph 56: Locked lid on leachate riser pipe (locked lid installed fall 2007).

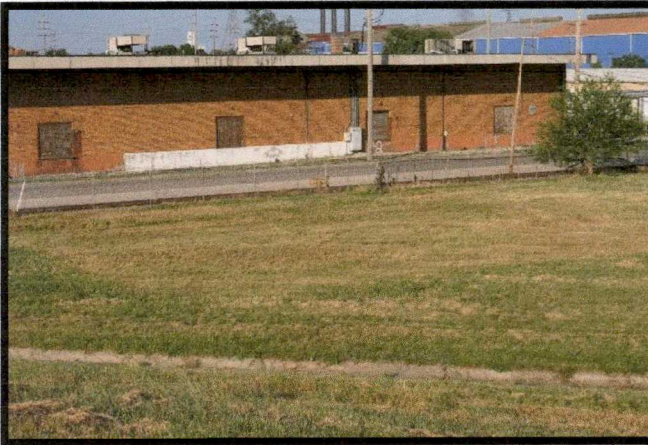
Photograph 57: Vegetation, former BV&G Truck Service area (view from Taracorp pile).

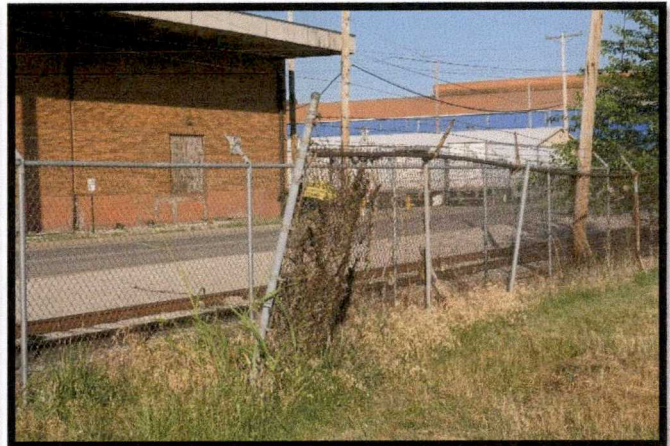
Photograph 58: Older and newer fence near former BV&G Truck Service buildings and along railroad tracks (view east).

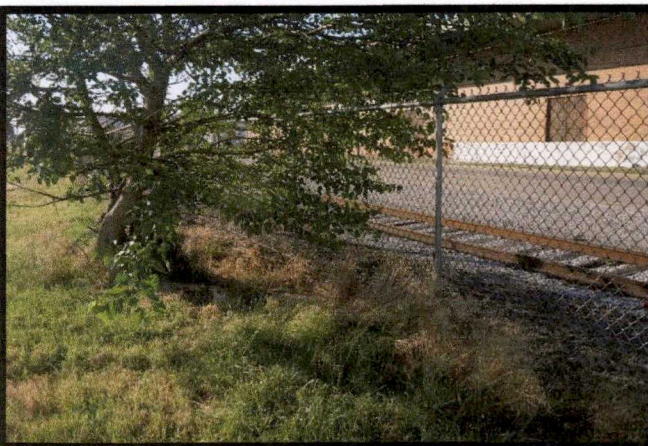
Photograph 59: Older and newer fence near former BV&G Truck Service buildings and along railroad tracks (view northwest).

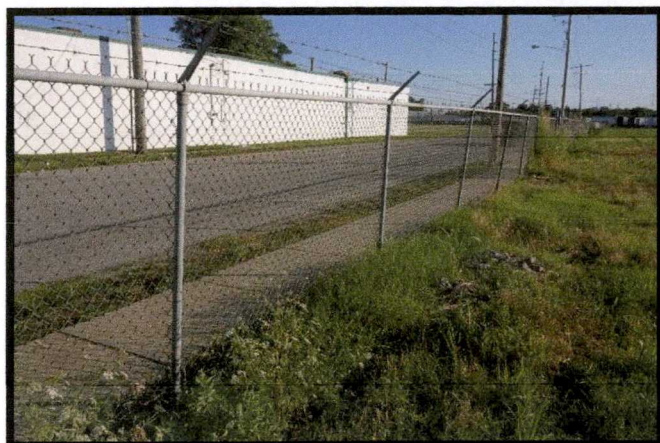
Photograph 61: Inside fence, view along State Street.

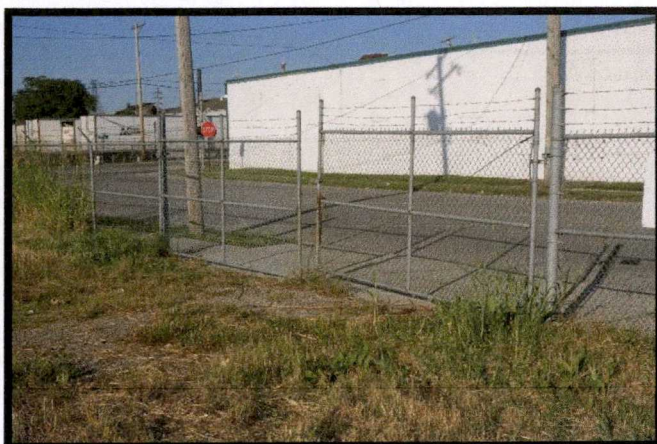
Photograph 62: Inside fence, gate along State Street.

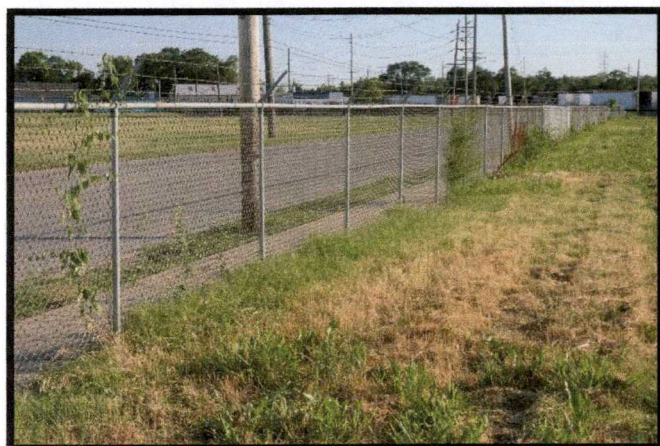
Photograph 63: Inside fence, view along State Street.

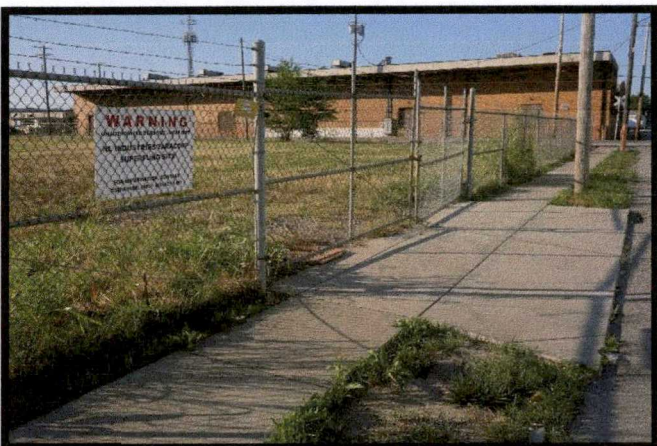
Photograph 64: Vegetation, fence, and warning sign along State Street sidewalk.

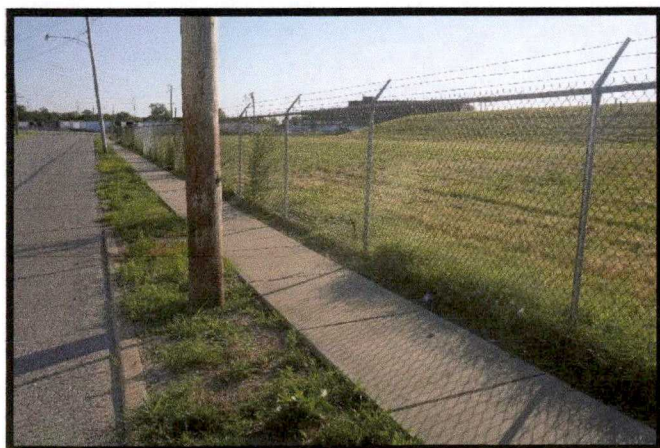
Photograph 65: Vegetation, fence along State Street sidewalk.

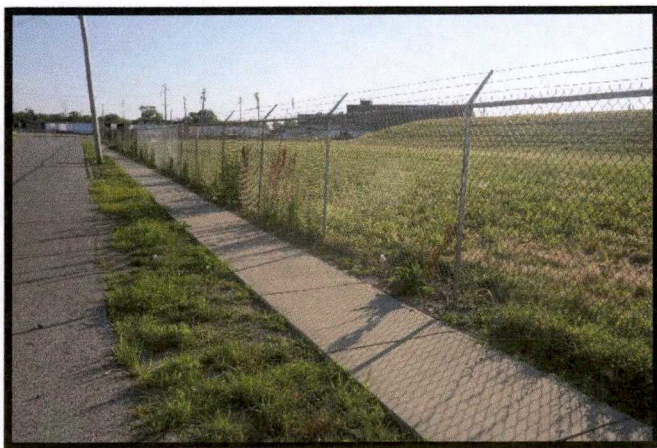
Photograph 66: Vegetation, fence along State Street sidewalk.

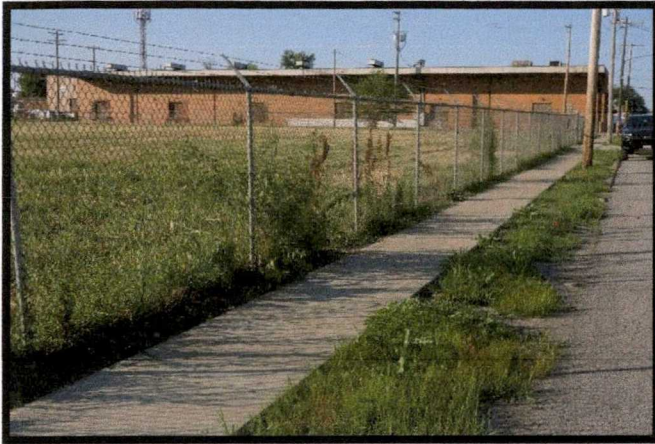
Photograph 67: Vegetation, fence along State Street sidewalk.

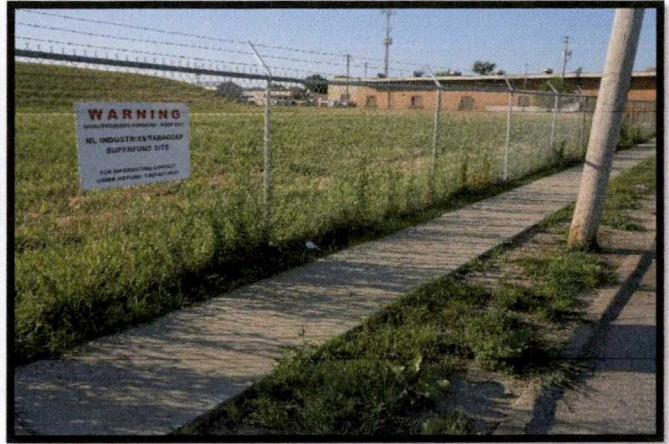
Photograph 68: Vegetation, fence and warning sign along State Street sidewalk.

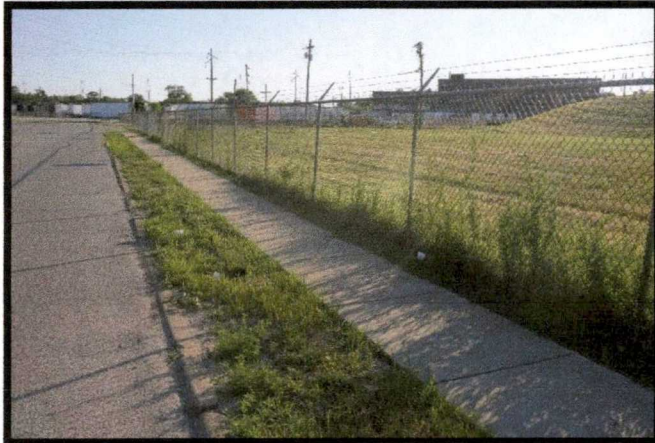
Photograph 69: Vegetation, fence along State Street sidewalk.

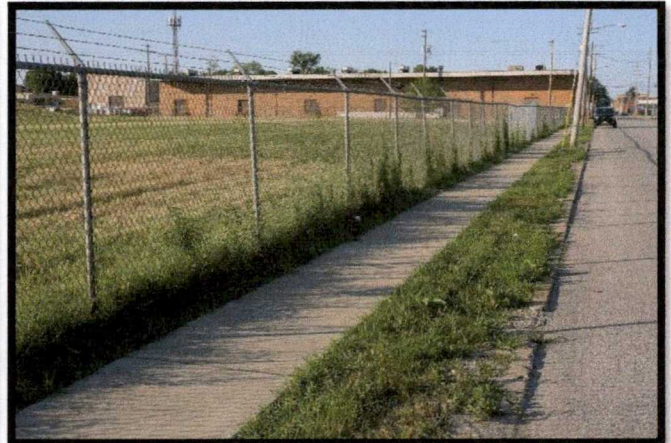
Photograph 70: Vegetation, fence along State Street sidewalk.

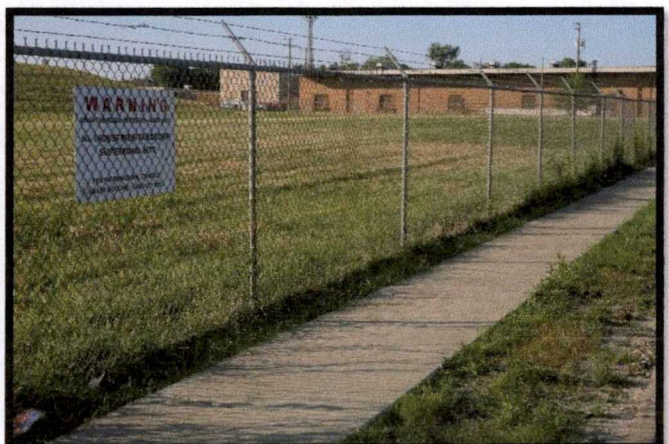
Photograph 72: Vegetation, fence, and warning sign along State Street sidewalk.

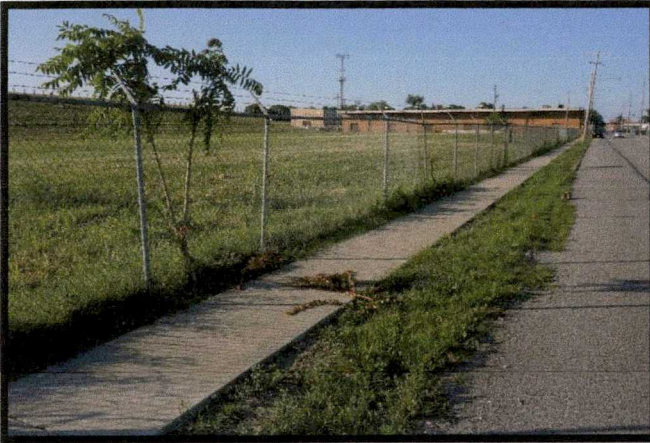
Photograph 73: Vegetation, fence along State Street sidewalk.

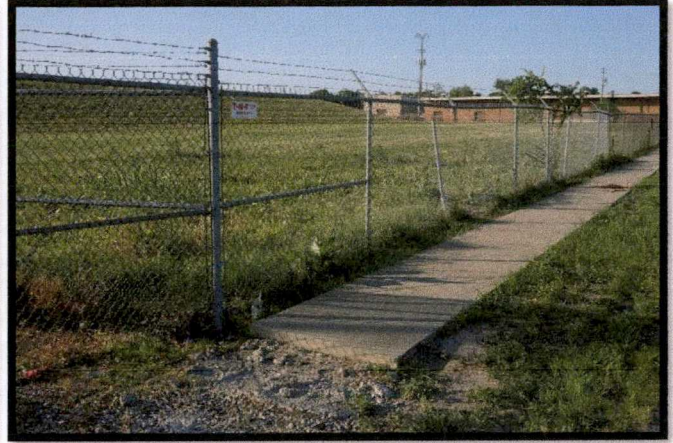
Photograph 74: End of concrete sidewalk at former Rich Oil property.

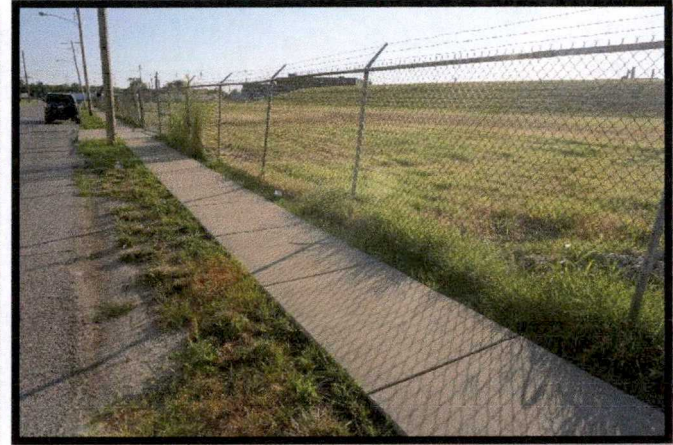
Photograph 76: Vegetation/fence along State Street sidewalk.

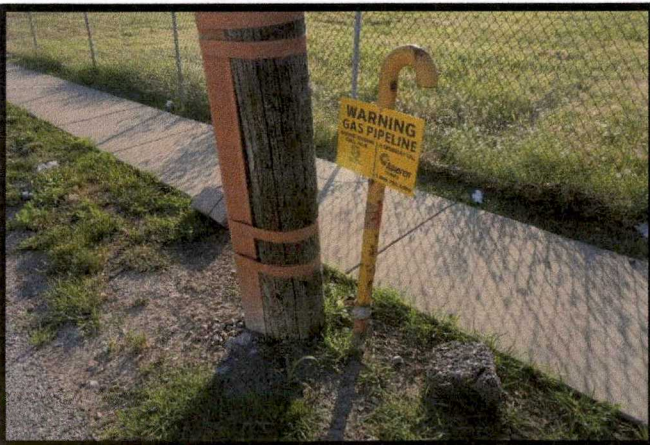
Photograph 77: Underground pipeline warning along State Street.

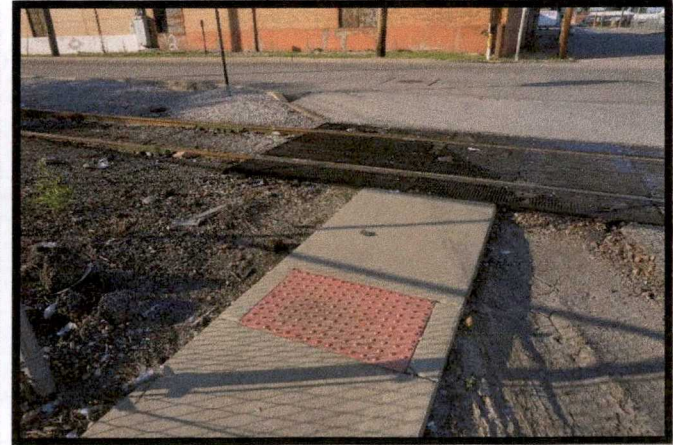
Photograph 78: ADA-compliant access ramp at end of sidewalk near railroad tracks.

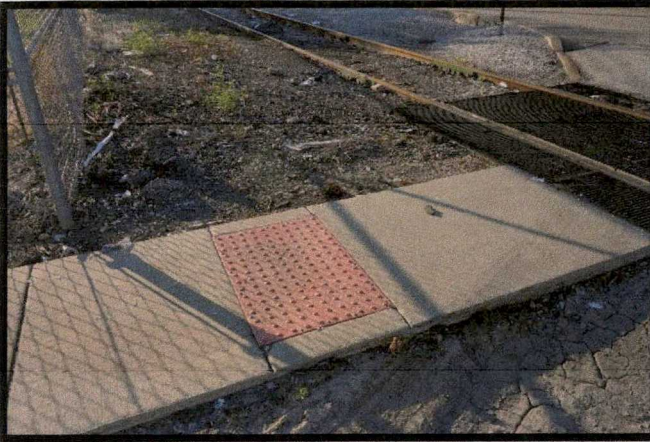
Photograph 79: ADA-compliant access ramp at end of sidewalk near railroad tracks.

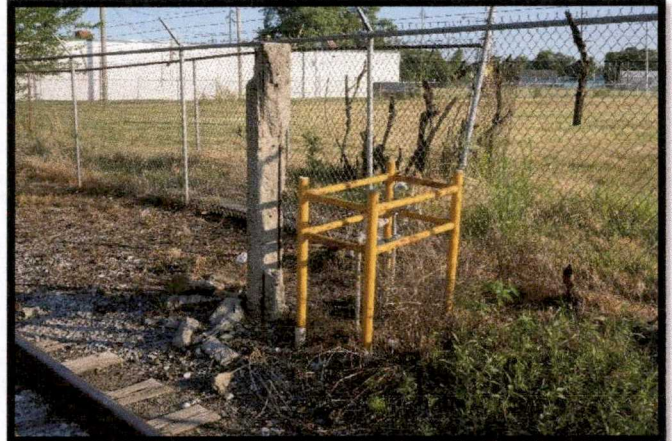
Photograph 82: Former gas utilities along railroad tracks.

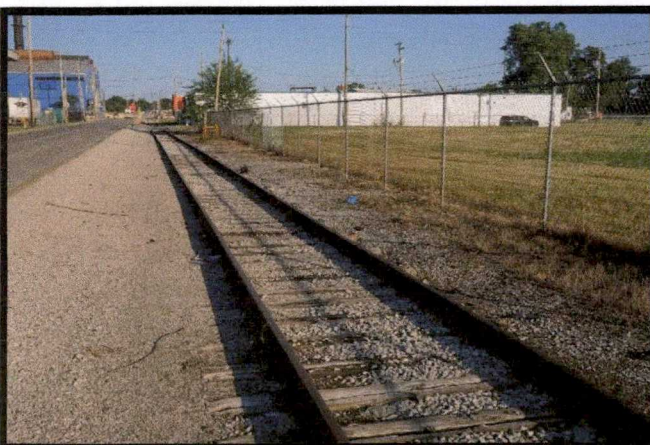
Photograph 83: Fence along railroad tracks and 16th Street.

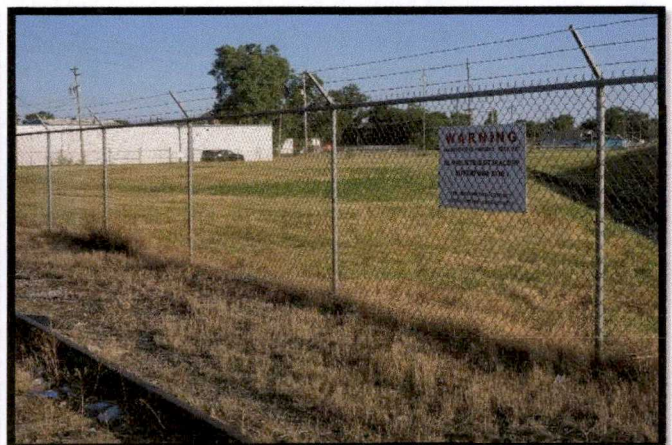
Photograph 84: Warning sign, fence along railroad tracks and 16th Street.

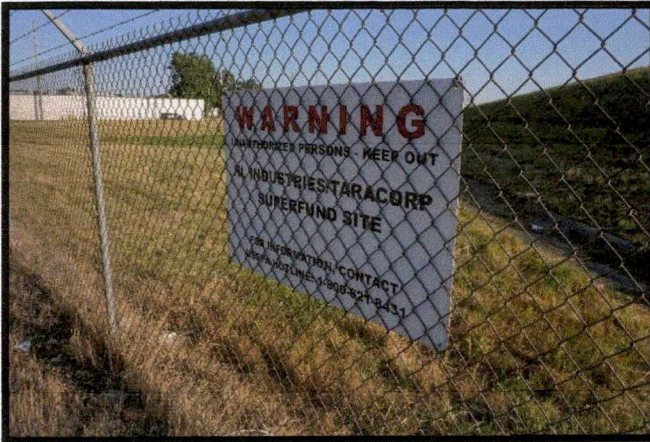
Photograph 85: Warning sign on fence along railroad tracks near 16th Street and Edison Avenue.

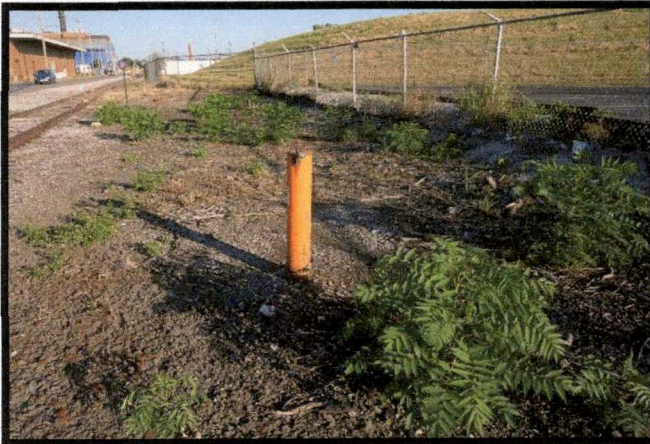
Photograph 87: Monitoring well MW-101.

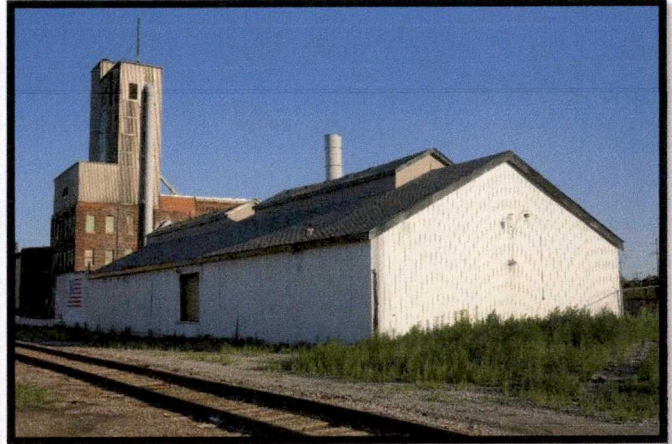
Photograph 88: Mayco facility along 16th Street.

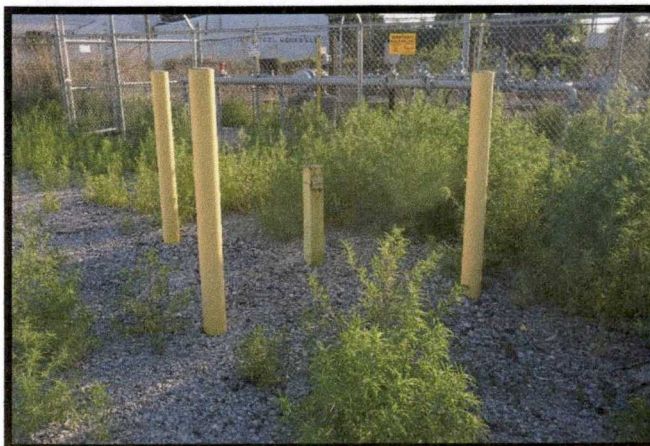
Photograph 89: Recently constructed bollards around monitoring well MW-105D.

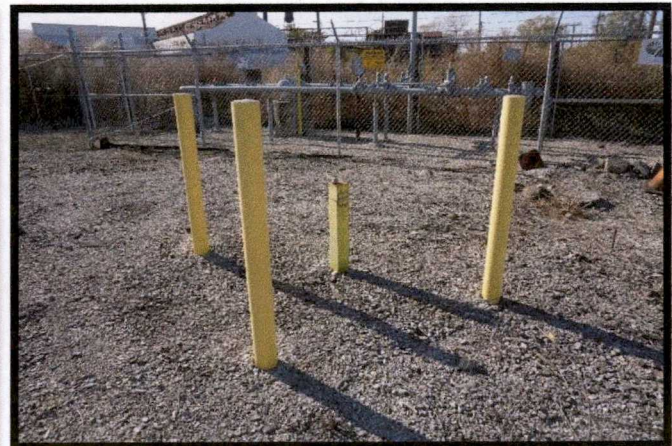
Photograph 90: Recently constructed bollards around monitoring well MW-105D.

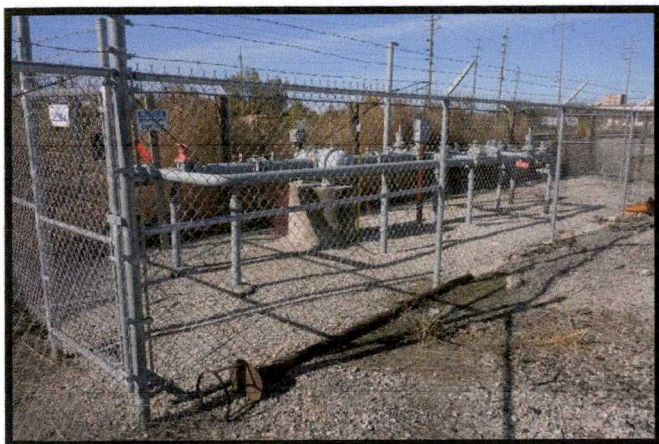
Photograph 91: Gas utilities near monitoring well MW-105D.

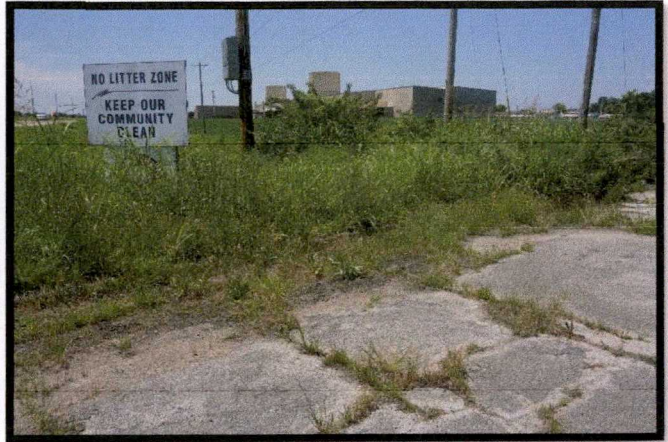
Photograph 2: Schaeffer Road property, entrance.

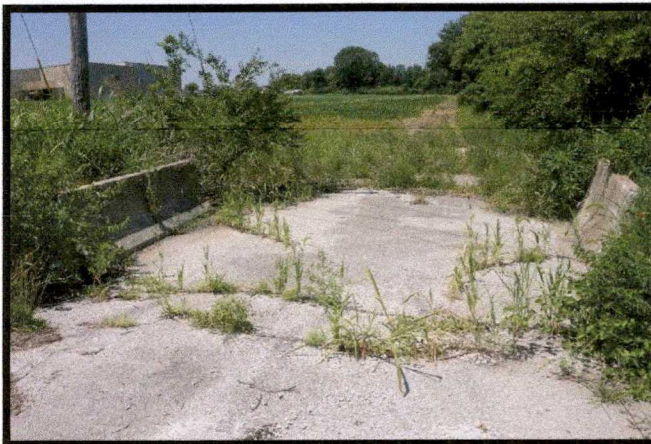
Photograph 3: Schaeffer Road property, entrance.

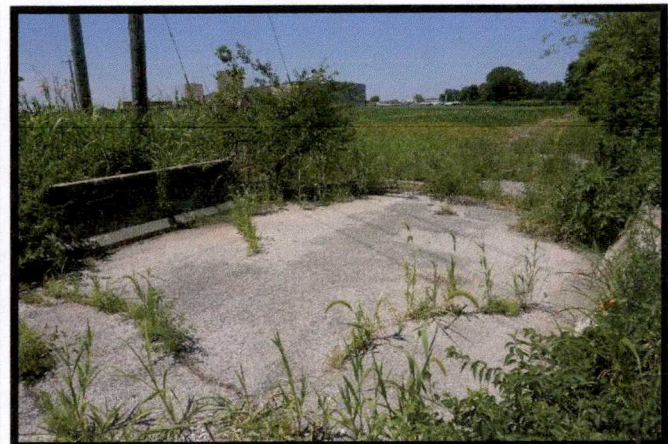
Photograph 4: Schaeffer Road property, entrance.

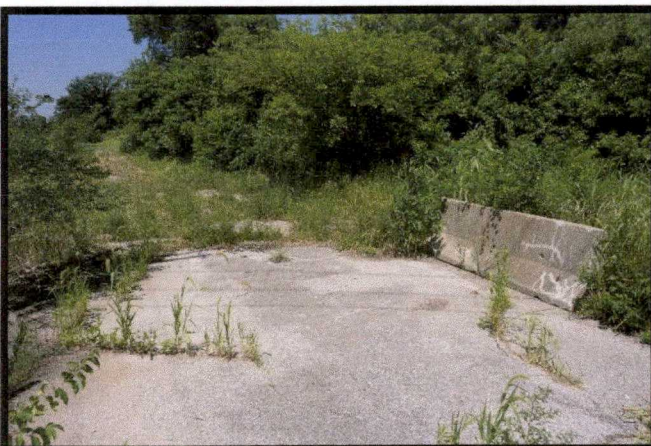
Photograph 5: Schaeffer Road property, entrance.

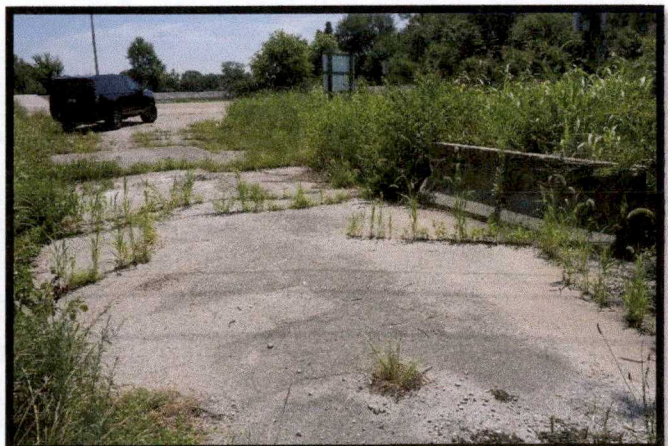
Photograph 6: Schaeffer Road property, entrance.

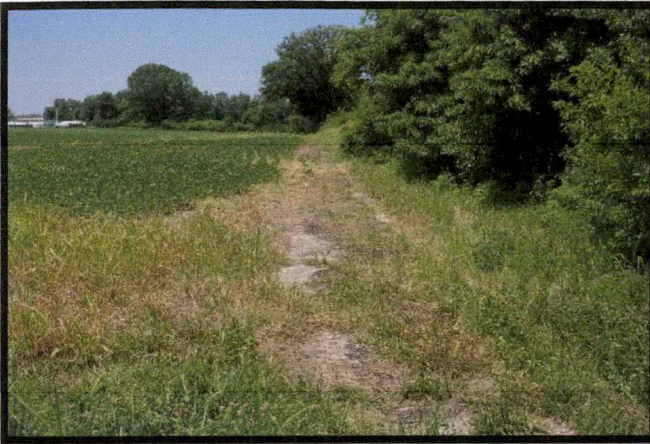
Photograph 7: Schaeffer Road property, roadway.

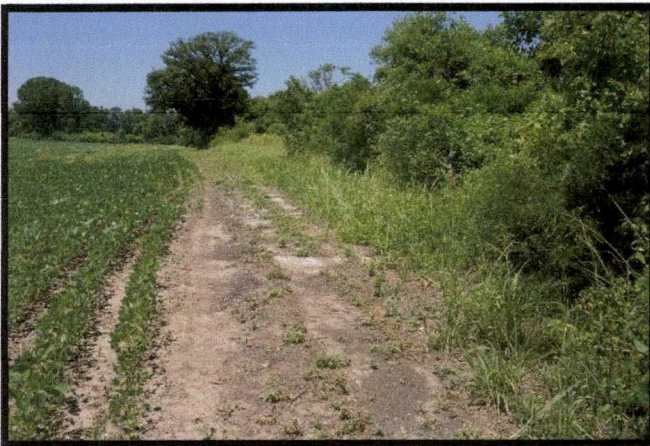
Photograph 9: Schaeffer Road property, roadway.

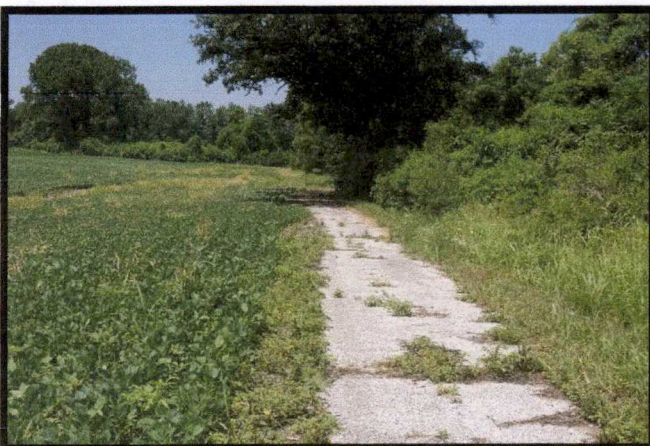
Photograph 11: Schaeffer Road property, roadway.

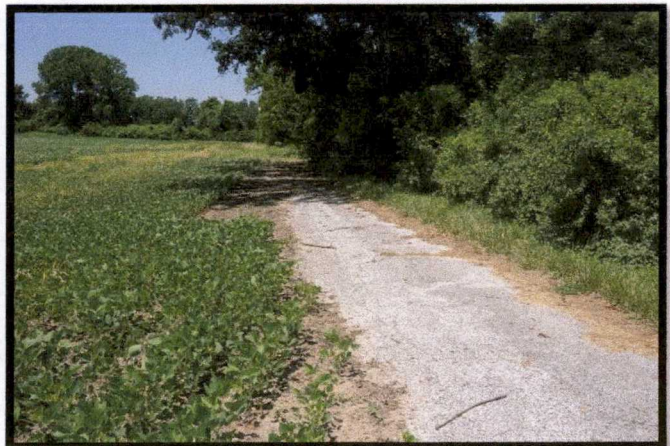
Photograph 12: Schaeffer Road property, roadway.

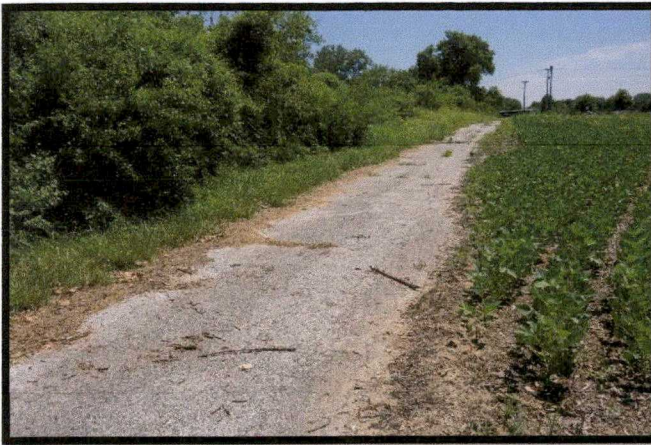
Photograph 13: Schaeffer Road property, roadway.

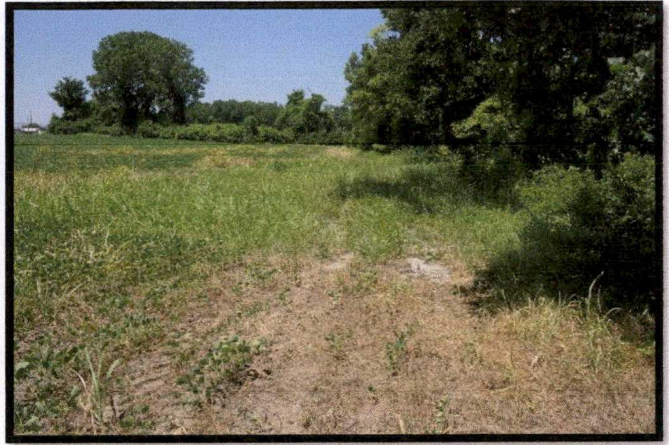
Photograph 14: Schaeffer Road property, roadway.

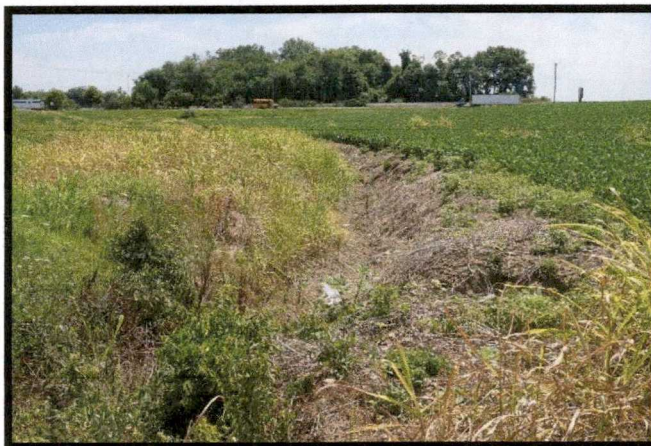
Photograph 15: Schaeffer Road property, stormwater drainage ditch.

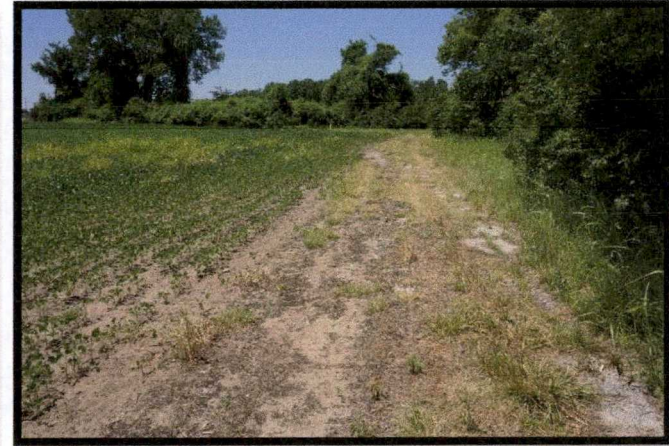
Photograph 16: Schaeffer Road property, roadway.

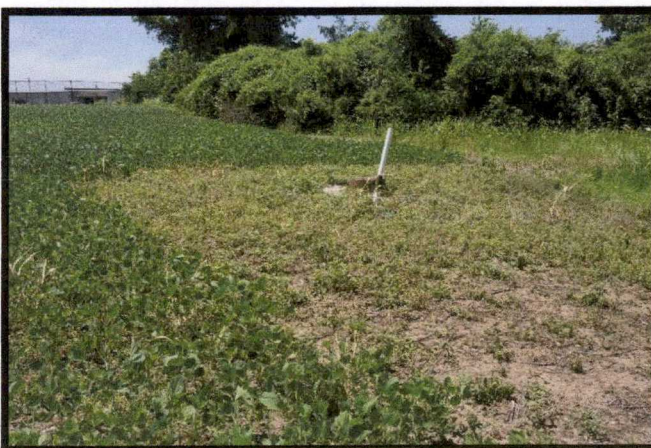
Photograph 17: Schaeffer Road property, vegetation near sanitary sewer manhole.

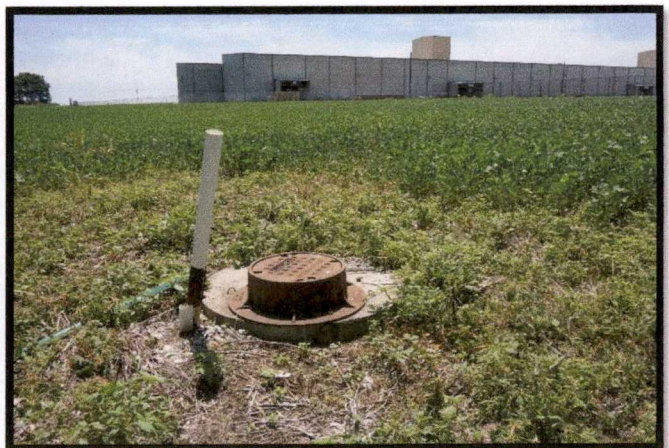
Photograph 18: Schaeffer Road property, sanitary sewer manhole.

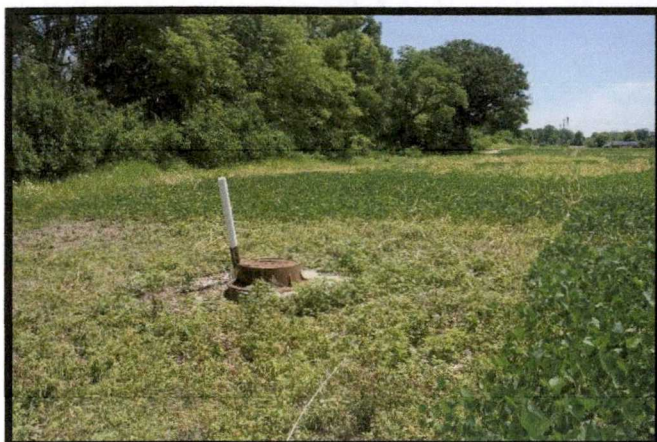
Photograph 19: Schaeffer Road property, field near sanitary sewer manhole.

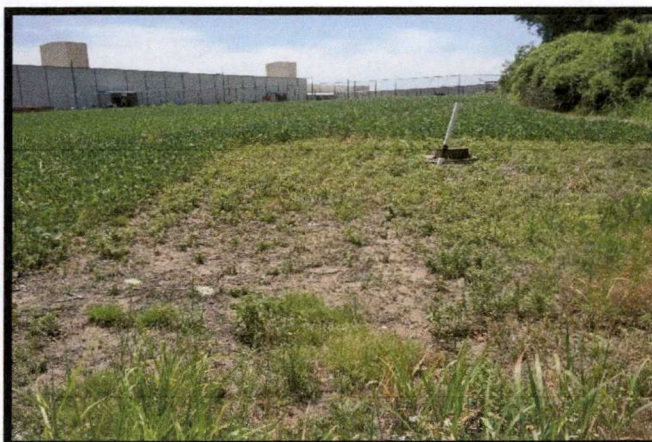
Photograph 20: Schaeffer Road property, field near sanitary sewer manhole.

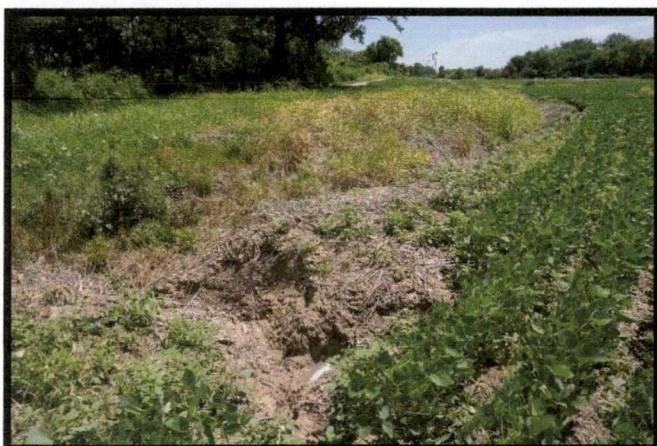
Photograph 21: Schaeffer Road property, stormwater drainage ditch.

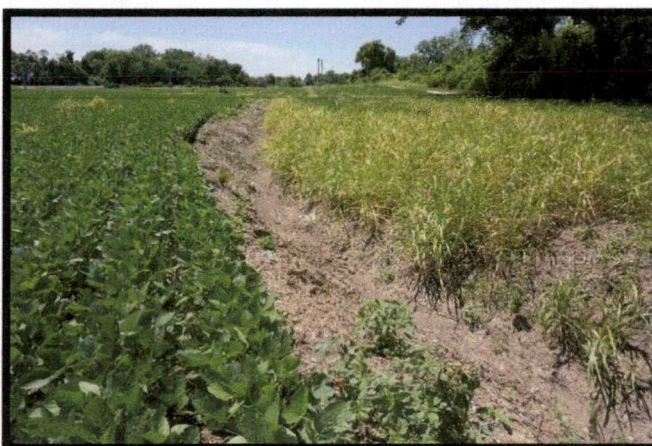
Photograph 22: Schaeffer Road property, stormwater drainage ditch.

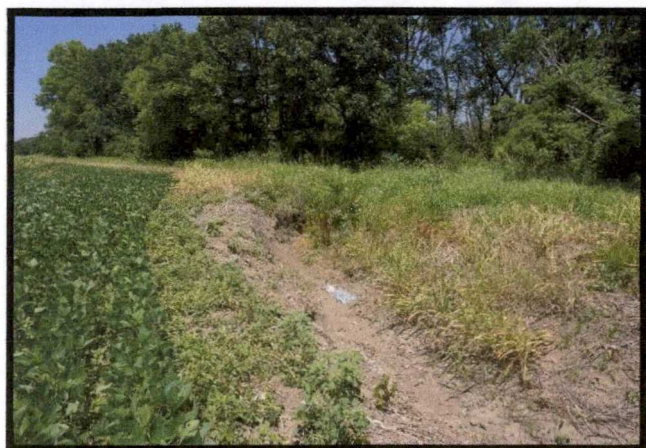
Photograph 23: Schaeffer Road property, stormwater drainage ditch.

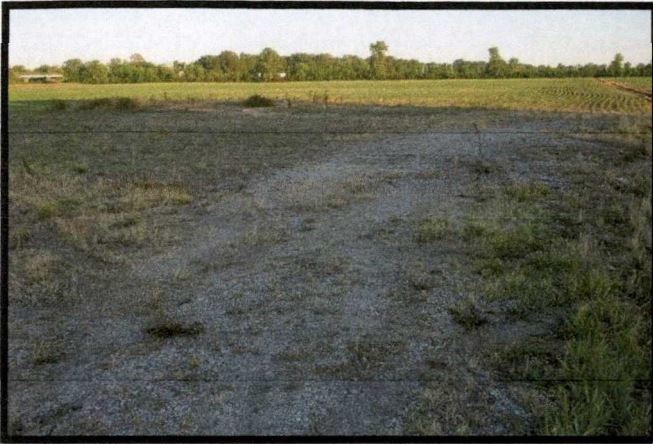
Photograph 1: Sand Road property (view from entrance).

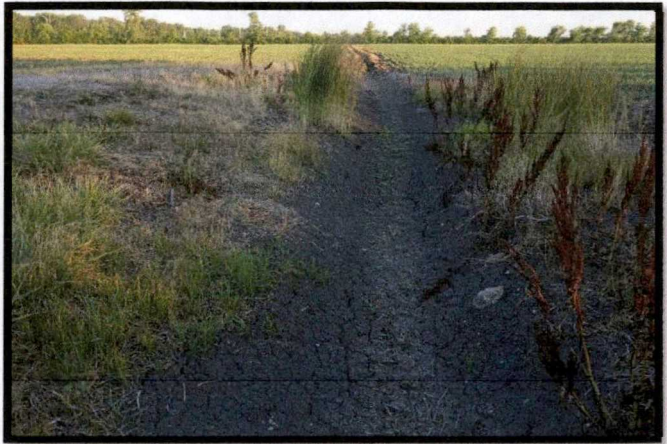
Photograph 2: Sand Road property, stormwater drainage ditch.

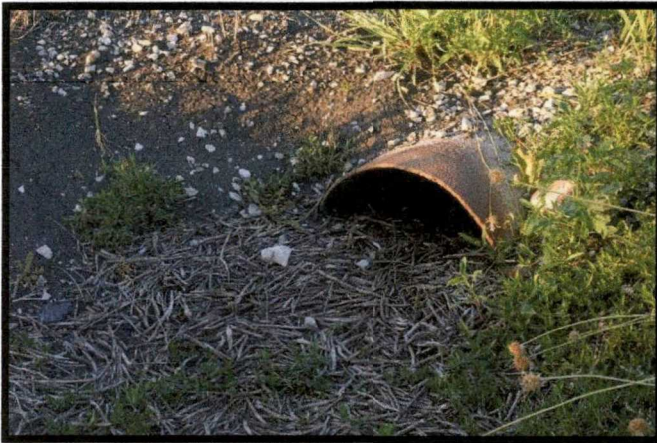
Photograph 3: Sand Road property, stormwater drainage ditch, pipe.

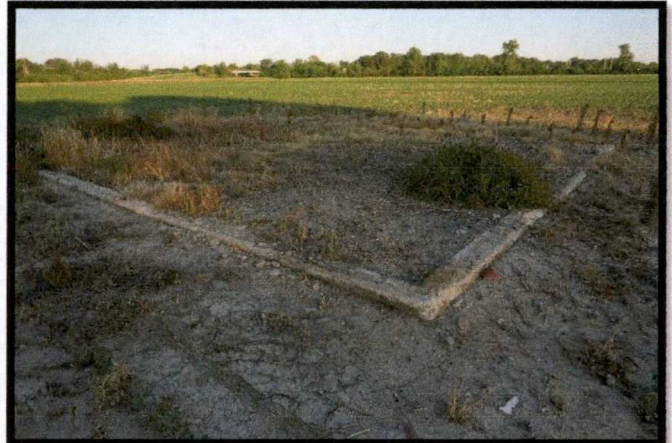
Photograph 4: Sand Road property, concrete foundation.

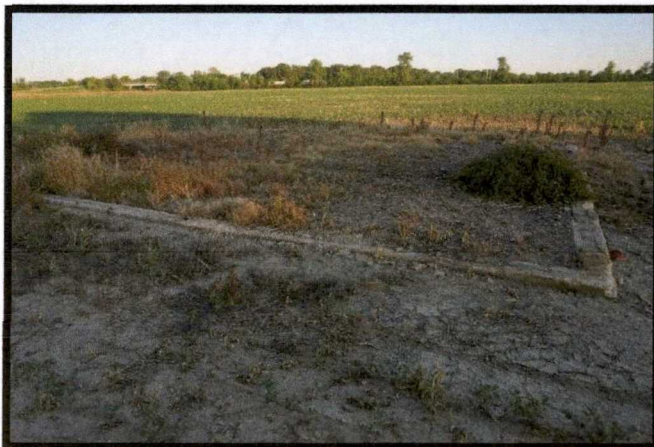
Photograph 5: Sand Road property, concrete foundation.

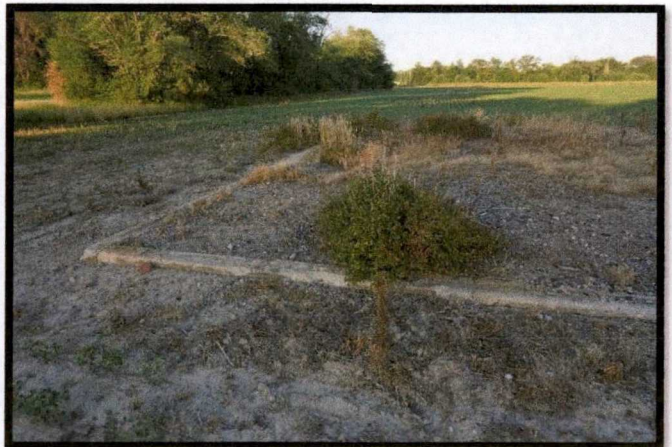
Photograph 6: Sand Road property, concrete foundation.

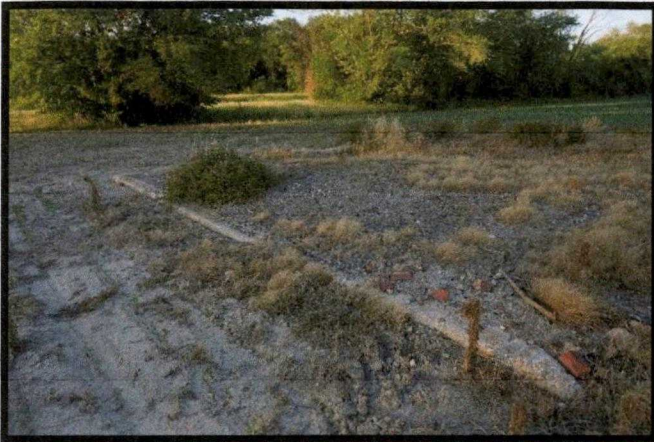
Photograph 7: Sand Road property, concrete foundation.

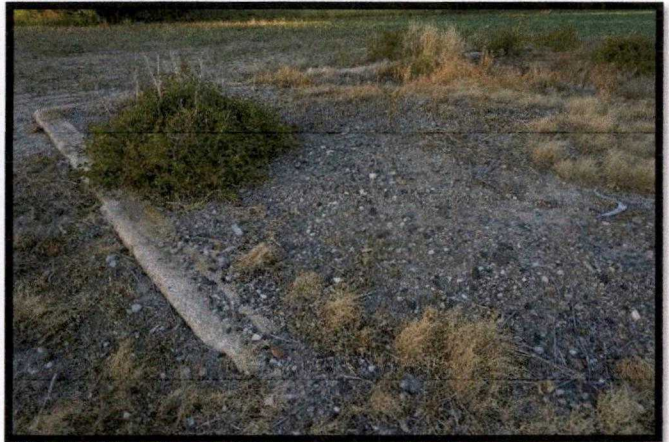
Photograph 8: Sand Road property, concrete foundation.

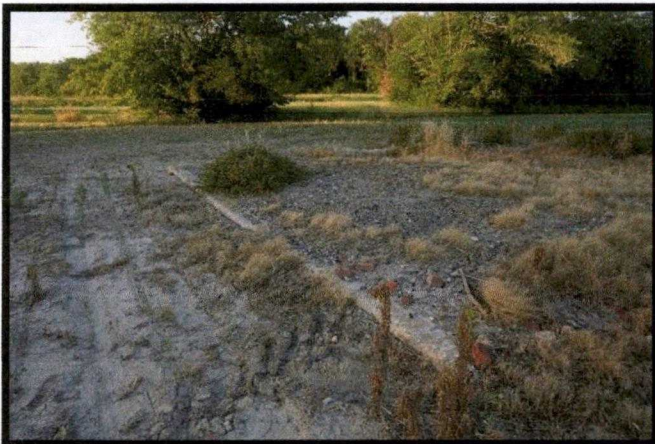
Photograph 9: Sand Road property, concrete foundation.

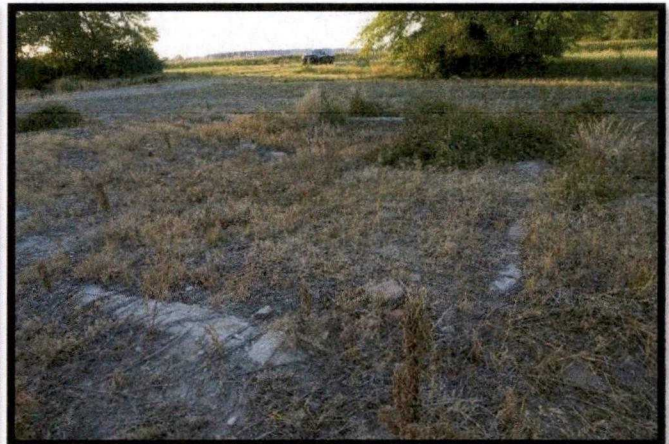
Photograph 10: Sand Road property, concrete foundation.

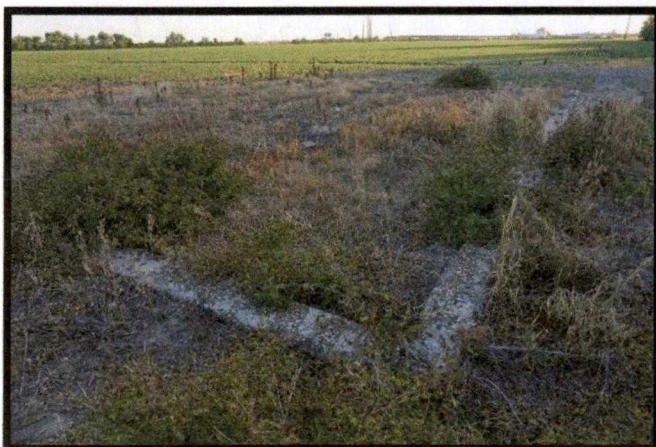
Photograph 11: Sand Road property, concrete foundation.

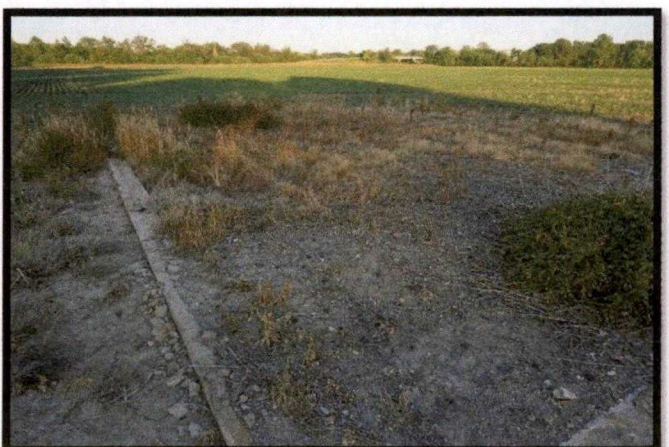
Photograph 12: Sand Road property, concrete foundation.

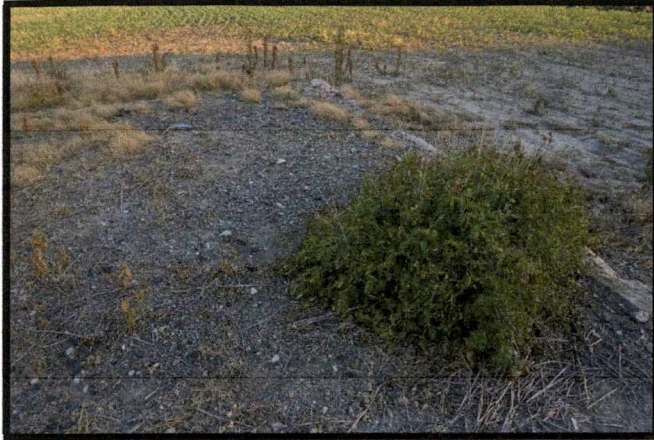
Photograph 13: Sand Road property, concrete foundation.
